## **Zambia Water Project**

In February 2016, Incoming International Director, Peter Durrant returned from his second visit to Ndola, where he was able to inspect the recently completed Zambia Water Project, successfully undertaken by the club.

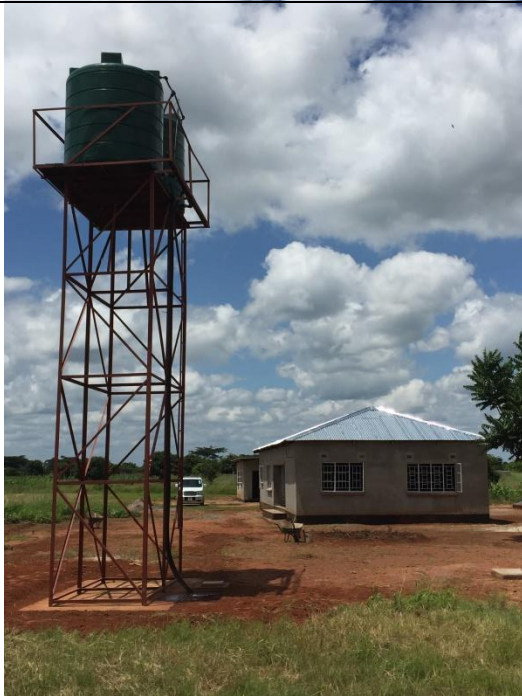
This is the tank stand 8M in the air with 2 x 5 KLt tanks providing the head of pressure for gravity feed around the site

The building in the background was the second one to be built and is ostensibly a store room at the moment, however, it will serve as offices and store rooms in the future. The diesel generator is temporarily housed in this building as is the control electrics.

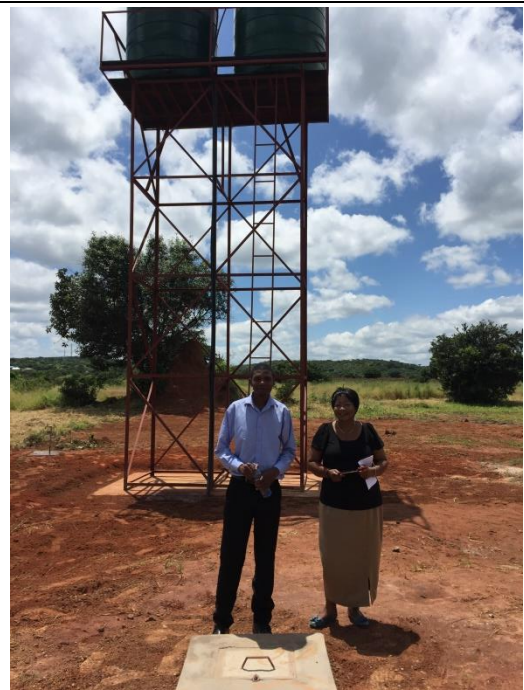
Here is Joyce Chimbila one of the most amazing ladies you will ever meet and on her right is Mumba Kolala an ex-Rotaractor and soon to be Rotarian. Mumba is the District Water Officer with the Ministry of Energy & Water Development, Department of Water Affairs and he was the one who finalised this project with his ingenuity and some money from us

In front of Joyce & Mumba is the top of the borehole with a lockable lid. The cable to power the submersible pump is underground from the building shown in the left hand side photo

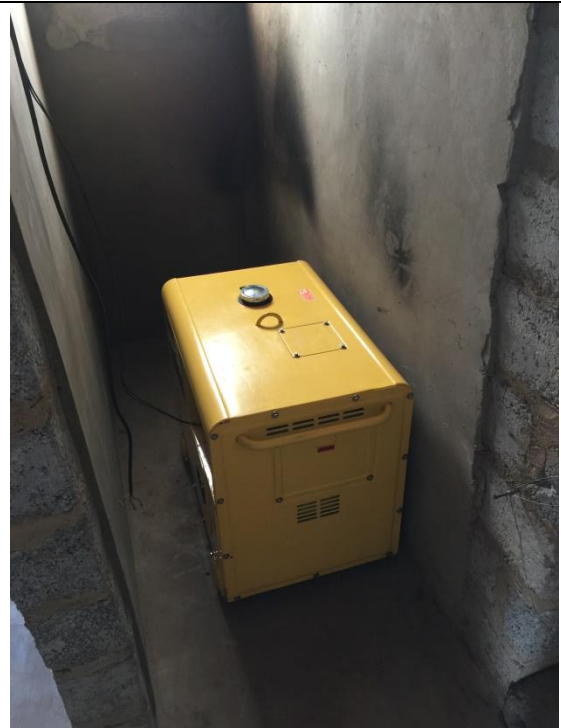
Here above is the power & control equipment for the submersible pump. For protection Mumba installed a liquid relay. Installation of liquid relays is a provision that will make the pump stop running whenever the water levels falls below the reach of the pump, but will automatically resume running immediately the water levels in the borehole has adequately recovered. The external cabling is temporary as mains power will be connected in due course.

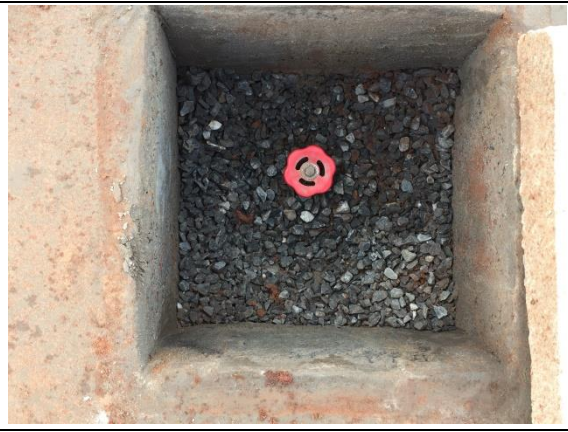
Above shows the base of the tank stand and the concrete box in front is where the stop cock is installed

The stop cock is the shut off for the head of water coming from the tanks to isolate the system should that be necessary

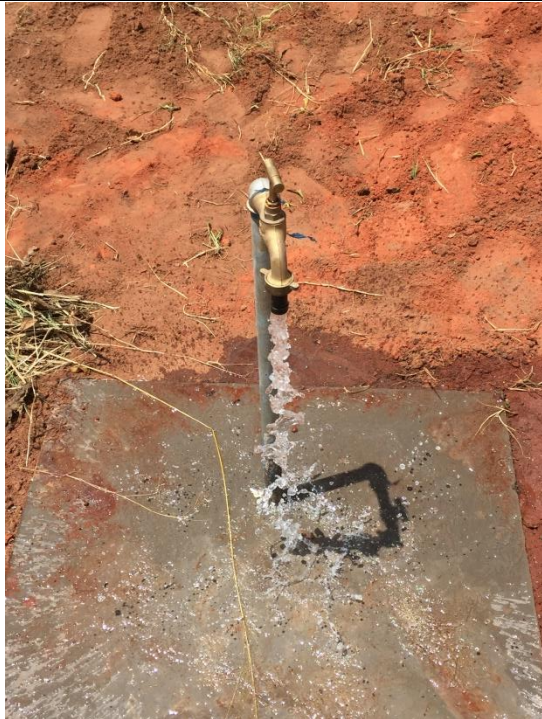
There are a number of standpipes around the site well constructed and interconnected underground – sited on concrete plinths. Below some perspective of the outlying area where the bore and tanks take pride of place

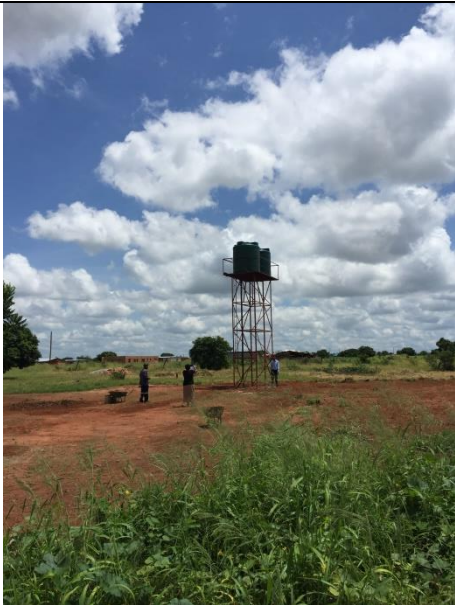
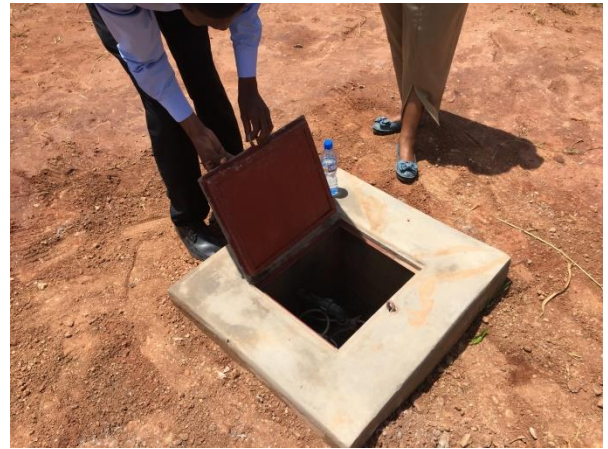
This is the top of the borehole into which the submersible pump is lowered and the power and control cabling connected. Below is the borehole cover with lockable lid, nicely set in concrete
